Small HVAC Problems and Potential Savings Reports

Summary of Problems in Each Building (product 4.5.1)

TECHNICAL REPORT

Element Four – Integrated Design of Small Commercial HVAC Systems Summary of Problems Observed in Field Studies of Small HVAC Units

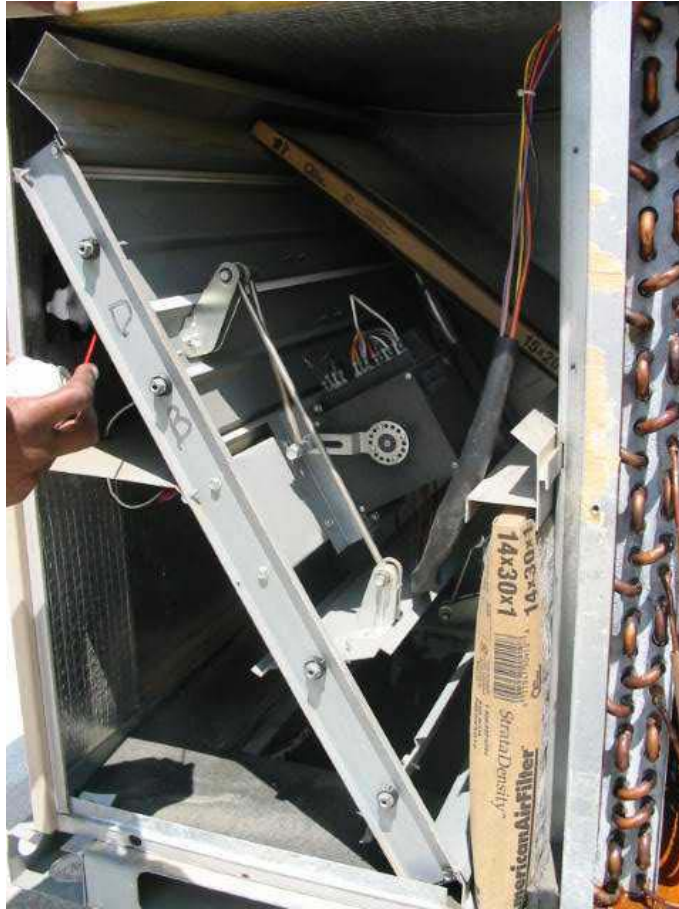
Figure 2. Cool spray (see red tube to left of “D” on damper assembly) used to cool down outdoor temperature sensor

Economizer. If the unit had an airside economizer, the minimum outdoor air position potentiometer was adjusted to test the operation of damper motors and linkages. The economizer outdoor air temperature sensor was cooled down using a “cool” spray, thus simulating cool outdoor air conditions. The response of the economizer was observed as the sensor was cooled, as shown in Figure 2.

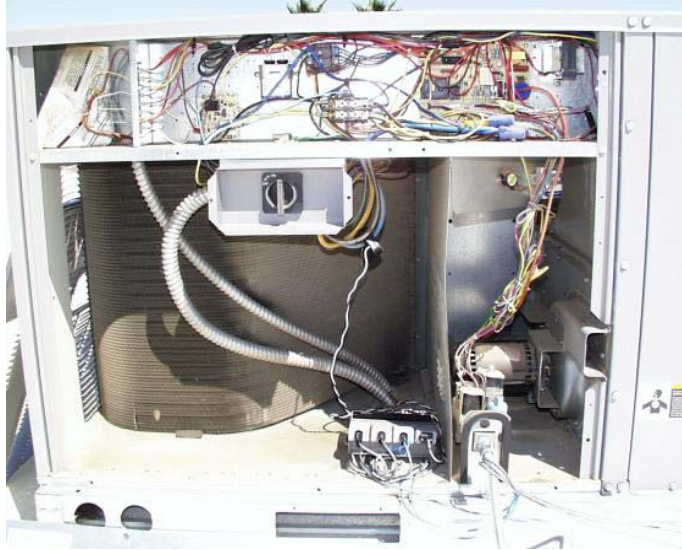
Figure 3. Unit prepared for short term monitoring using battery powered datalogger.

Selected units were monitored over a two to three week period using portable, battery-powered data loggers to observe unit operation over a variety of operating conditions. The datalogger was used to measure unit current, supply air temperature, return air temperature, and mixed air temperature. The data were observed instantaneously and stored on a five minute basis. The datalogger used thermistor sensors with a 0.5°F accuracy over the full range. The current sensors were equipped with signal conditioning equipment to provide true RMS current readings. True RMS current measurements were coupled with the spot kW and current measurements to estimate time series kW data for the unit. In addition to the datalogger installed at each unit, the local rooftop temperature and humidity was monitored at each site. Diagnostic software was used to analyze the short-term monitored data.

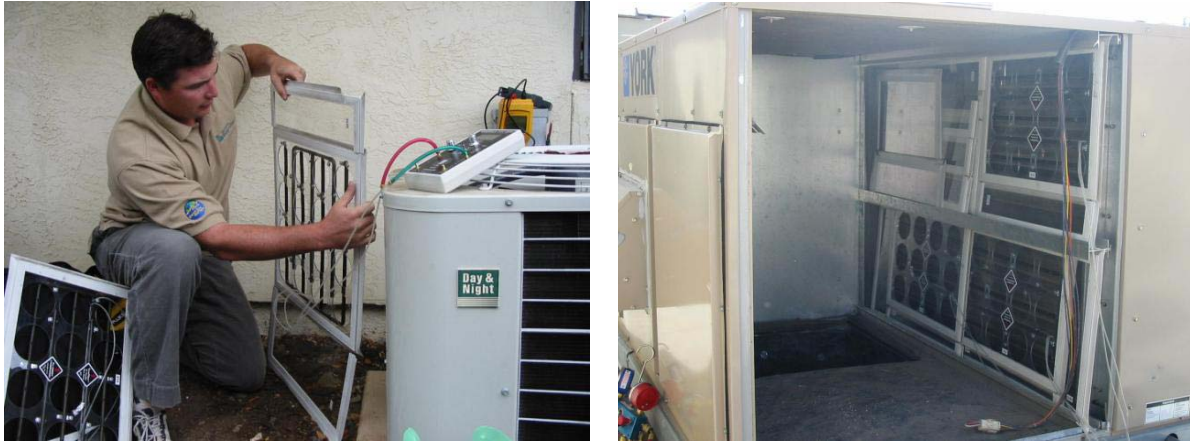
Figure 4. Flow Grids used to measure unit flow rate. Flow grid assembly and digital micromanometer are shown on the left. Flowgrid installation in place of unit filters is shown on the right.

The unit was cycled through each mode of operation (standby, fan-only, cooling stage one, and cooling stage two, if applicable) and the true electric power and current of the unit were measured during each mode using a portable wattmeter. Airflow rate was measured using a flow grid, which is an averaging flow meter designed to be installed in place of the filters. A digital micromanometer measures the pressure drop across the plate, and reads out directly in cfm. The manometer was also used to measure supply static pressure, return static pressure, and total unit external static pressure.

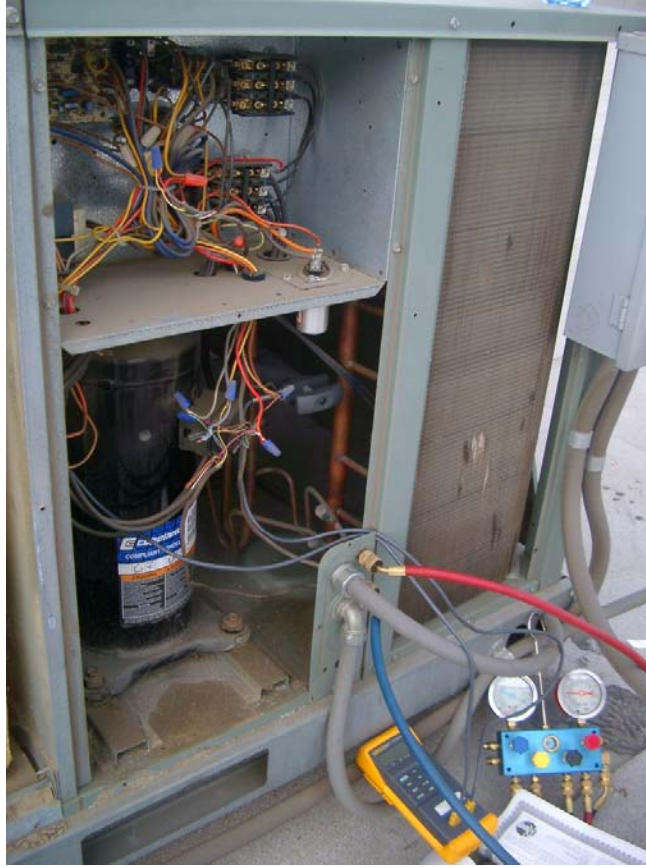
Figure 5. Refrigerant gages and digital temperature meter set up in preparation for conducting CheckMe test.

Service gauges and temperature sensors were used to verify the state of charge of the rooftop unit using the CheckMe!¹ Procedure. The high side and low side pressures were measured, along with the suction line temperature, the condensed liquid temperature, outdoor drybulb temperature entering the condenser, and drybulb and wet bulb temperatures entering the evaporator coil. Refrigerant was added or removed from the system until the suction line superheat on units with fixed metering devices, or the condenser line approach or subcooling temperature on units with thermostatic expansion valves (TXV) was within the target specified by the CheckMe! software.

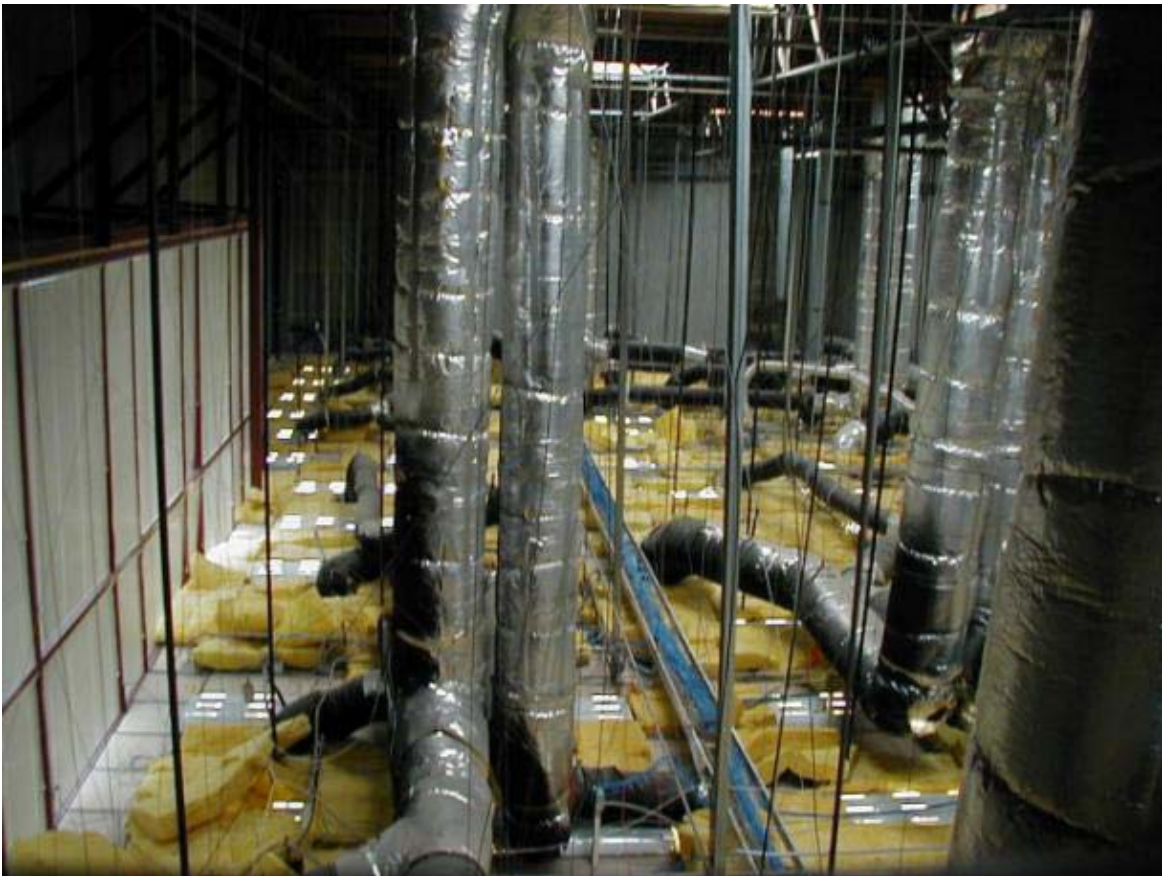
16% of systems had ductwork running through unconditioned spaces. Of those, 60% were in unconditioned plenums; the rest were outdoors. A common building construction practice is to install a dropped ceiling in an unconditioned, high-bay warehouse to create conditioned office space. Ductwork is run from the rooftop units through a large unconditioned area to serve the offices below. This ductwork should be well-insulated and sealed against leakage to minimize duct losses to the unconditioned space. The photo below shows ductwork located in an unconditioned space, and lay-in insulation placed over the dropped ceiling tiles. Note the poor insulation coverage and the extensive use of flex duct in the distribution system.

Figure 14. Lay-in insulation and ductwork in an unconditioned space serving the conditioned office area of a high-bay unconditioned warehouse.

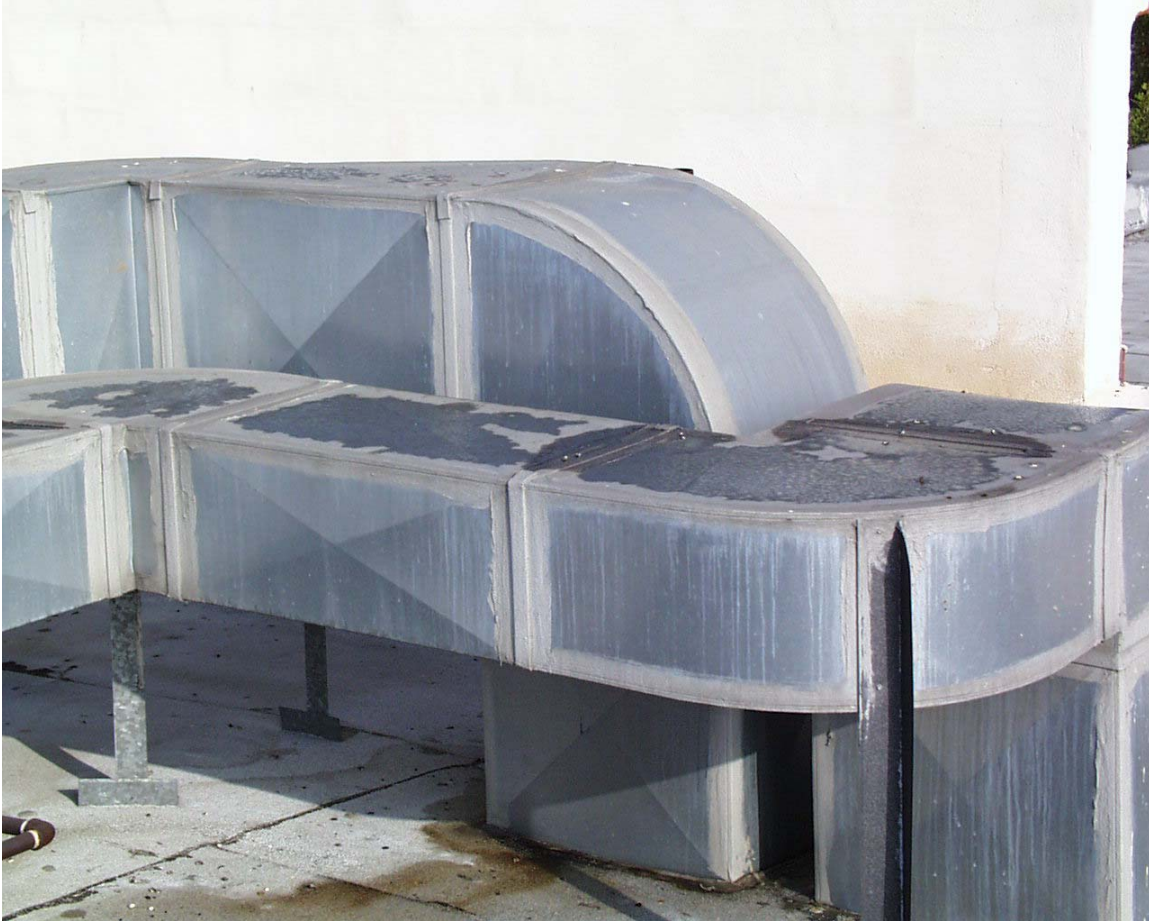
Several sites were also observed with ductwork running across the roof surface. Although this practice is allowed under the Title 24 Energy Standards, the ductwork should be well-insulated, weather-proofed, and sealed against duct leakage to minimize distribution system losses.

Figure 15. Ductwork located Outdoors

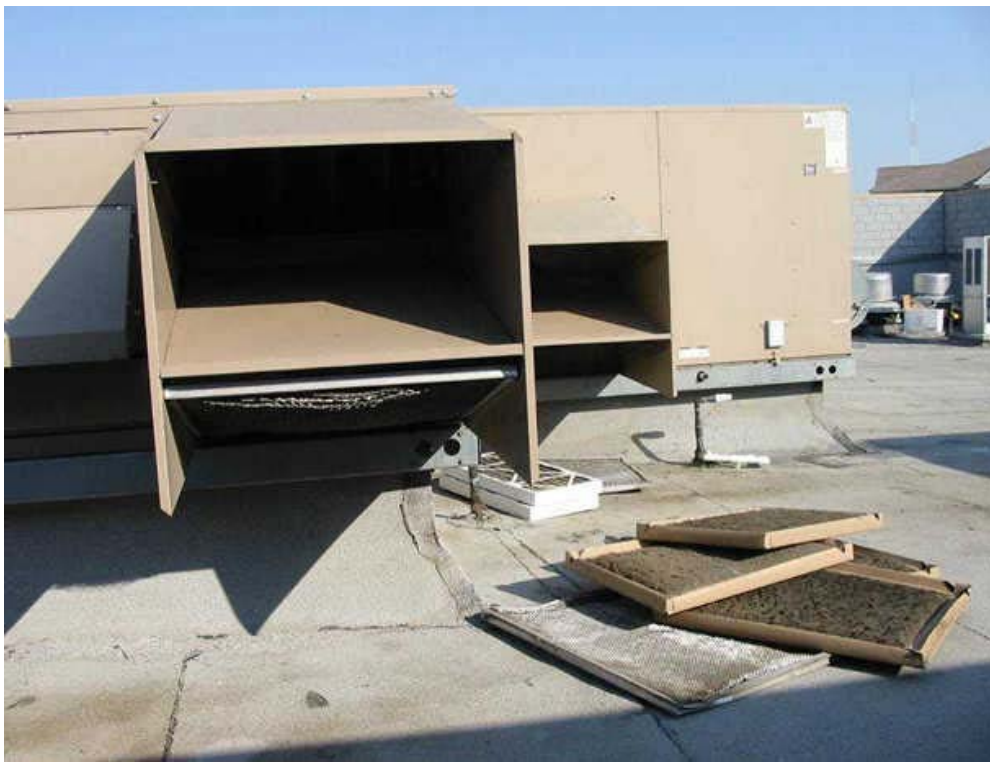
The following photos were taken at a newly constructed restaurant soon **after** a visit by the HVAC service contractor. The roof was littered with old, filthy filters and bent and discarded “bird screens” intended to protect the unit’s outdoor air opening.

Figure 16. Poor Maintenance Practices.

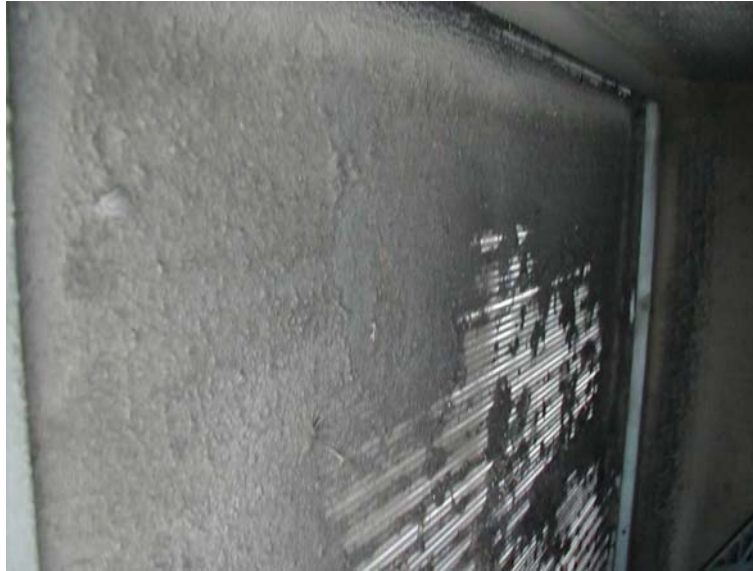
A closer inspection revealed several instances of missing filters and filthy cooling coils.

Figure 17. Dirty Evaporator Coil Due to Lack of Maintenance

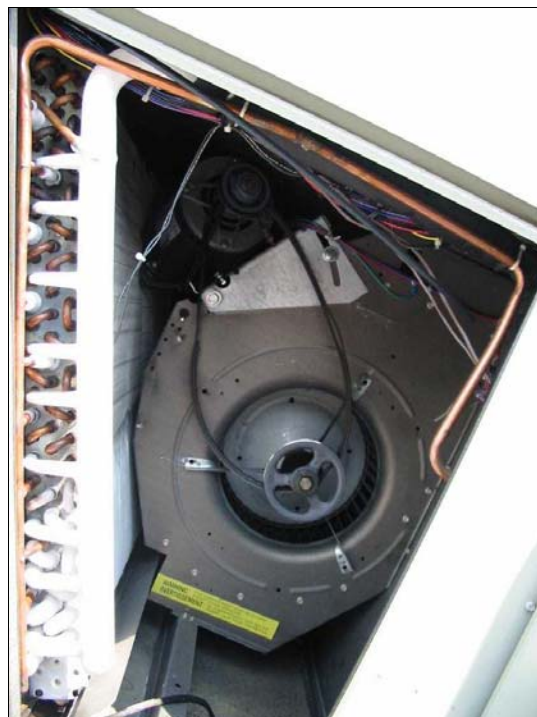
This fan motor fell off its mounting and into the evaporator coil. Although refrigerant wasn't lost, there was no airflow. Comfort complaints that went on for weeks were blamed on a thermostat problem. A simple check of the system would have discovered this problem much earlier.

Figure 18. Fan Motor Mount Failure

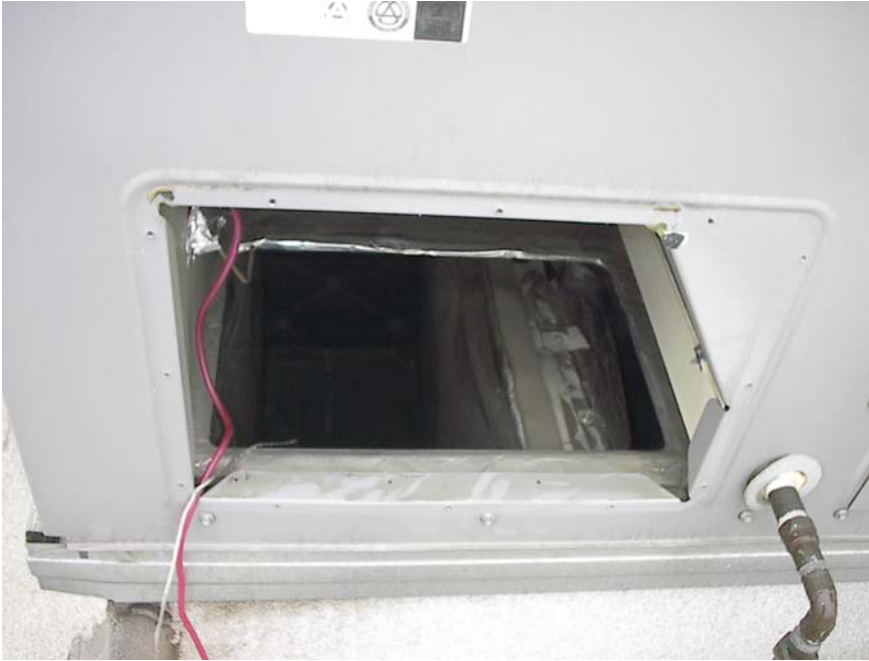
Incompatible unit and curb design. All units observed at this site were set on an incompatible curb, where the supply and return duct connections did not line up with the unit supply and return compartments. Significant supply air bypass into the unit return was the result. The bypassed supply air reduces unit capacity and efficiency.

Figure 20. Misalignment of unit supply and return outlets with building ductwork

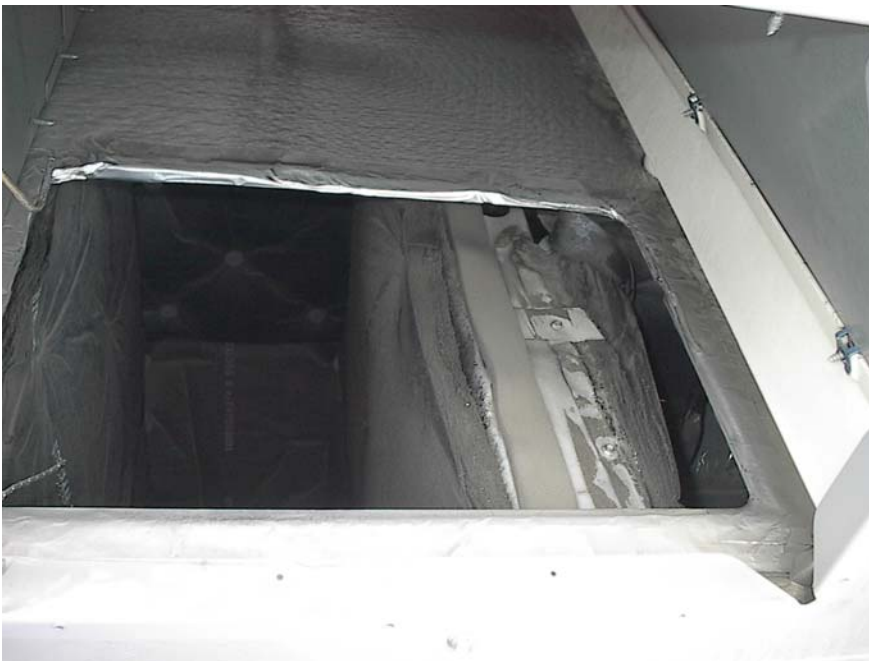
Figure 21. Close-up of unit supply plenum showing bypass into return side

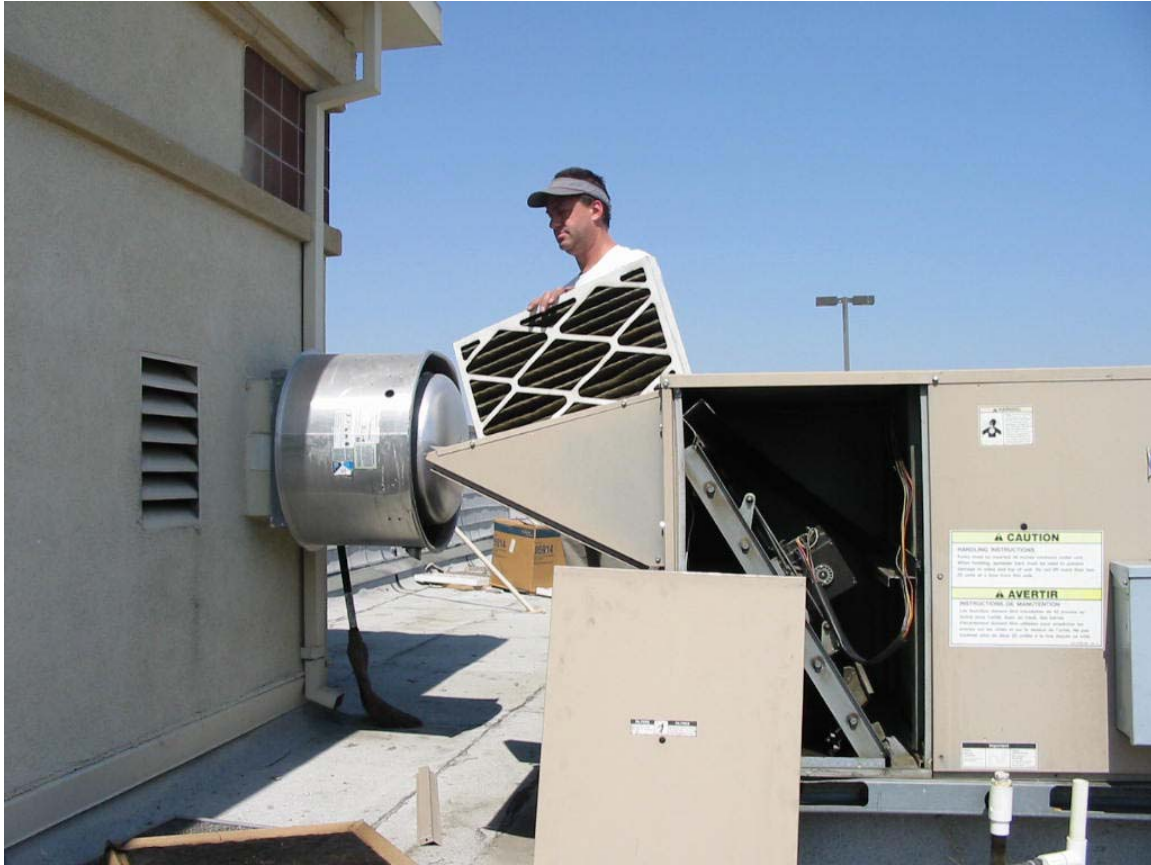
Outdoor Air Intake Adjacent to Exhaust Fan. This toilet exhaust fan was discharging directly into the outdoor air intake of a rooftop unit. Ventilation air contamination and odor problems result from this design flaw.

Figure 22. Exhaust Fan Discharge Into Outside Air Intake

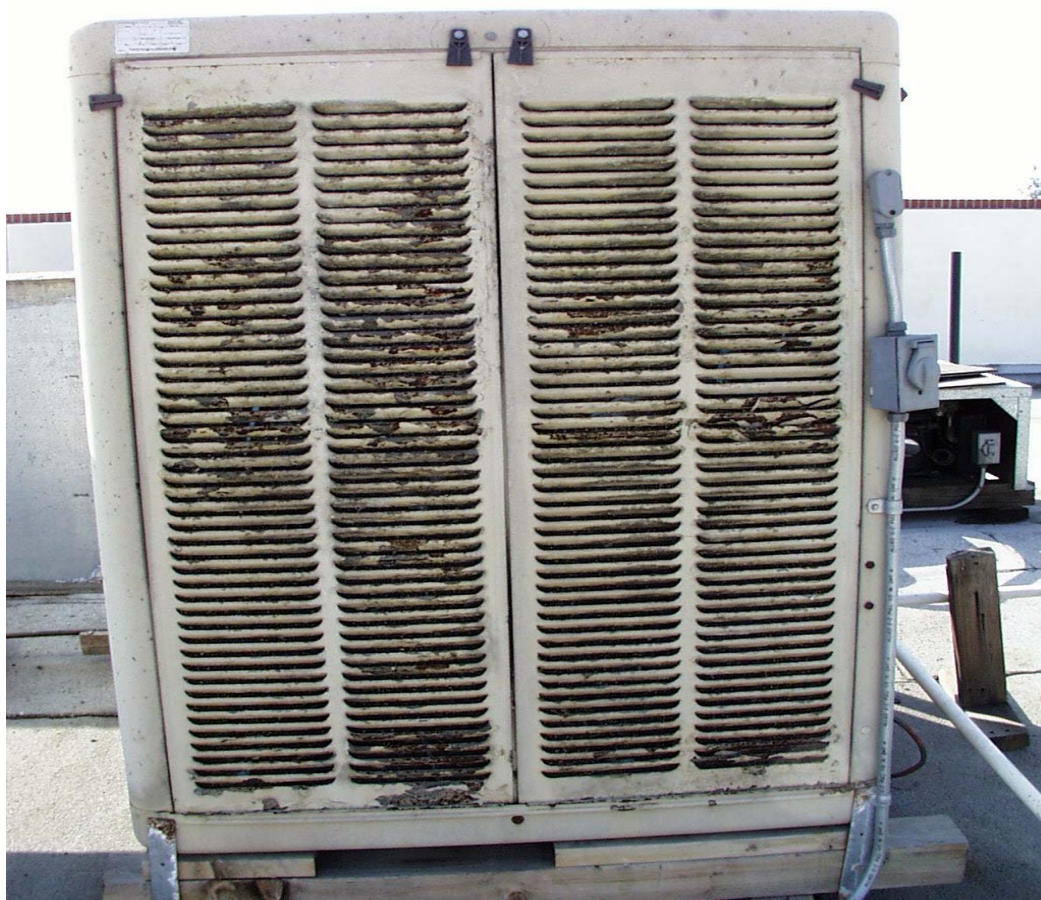
Grease-Clogged Equipment

The units appear to need servicing and cleaning. The grease in the exhaust air from the kitchen has clogged many of the filters, hindering the ability of the units to function properly. The following image shows the grease build-up on the exterior of one of the units:

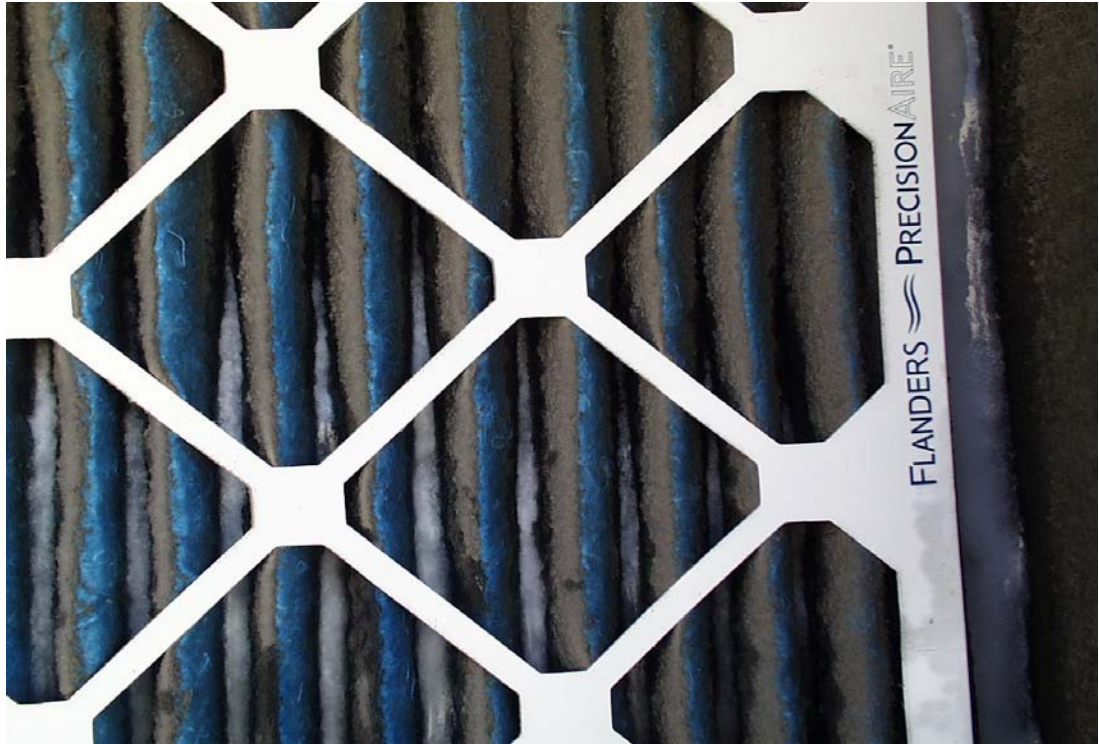
At the time of the site visit, one of the cooling coils had frozen up enough that ice was built up on the air filter. The supply air temperature in both of the units monitored was over 60 degrees F. At the time of the site visit in October the team of surveyors was unable to get two of the units to run. It is likely that there is something malfunctioning in these units.

Frozen Dirty Filter

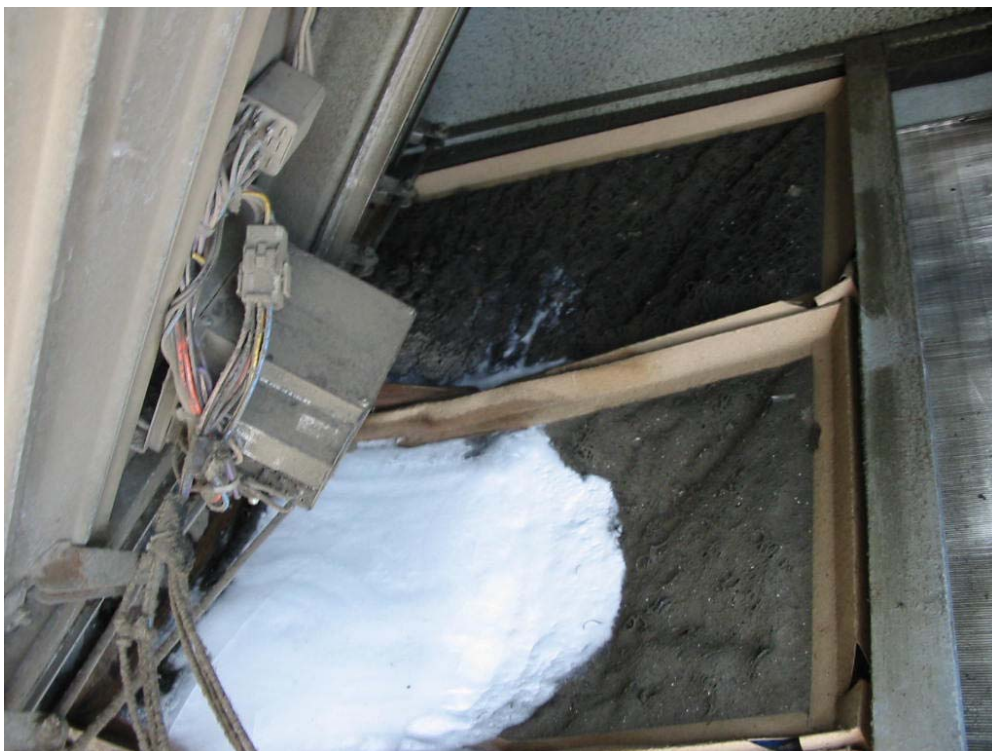
Filthy filters and iced evaporator coil

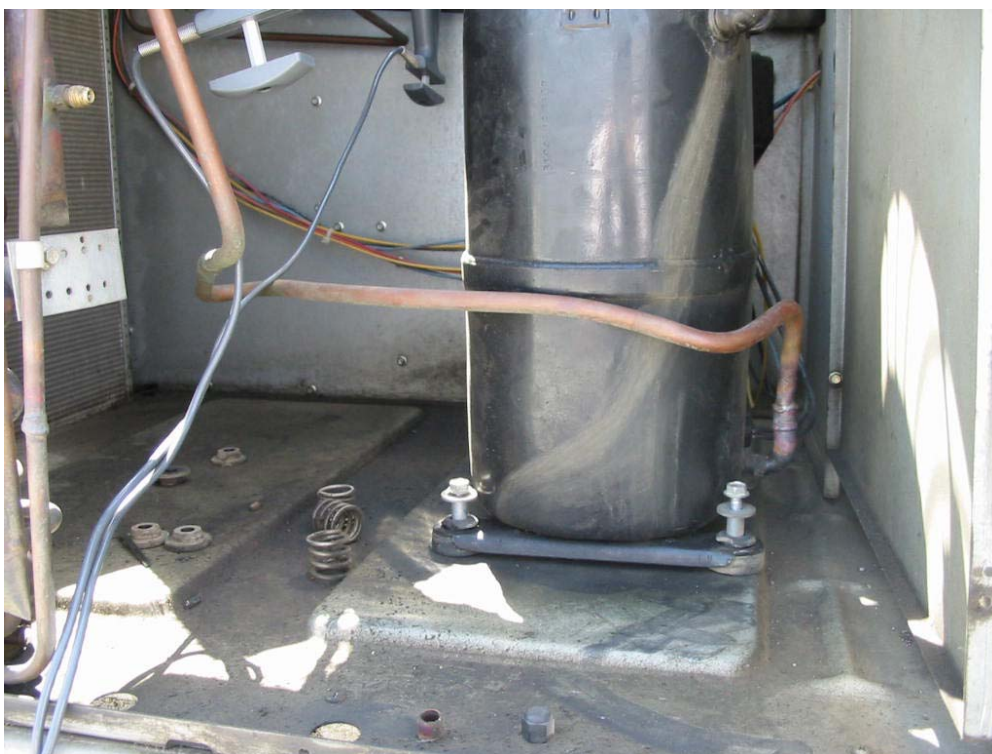
Missing vibration dampers on recently replaced compressor

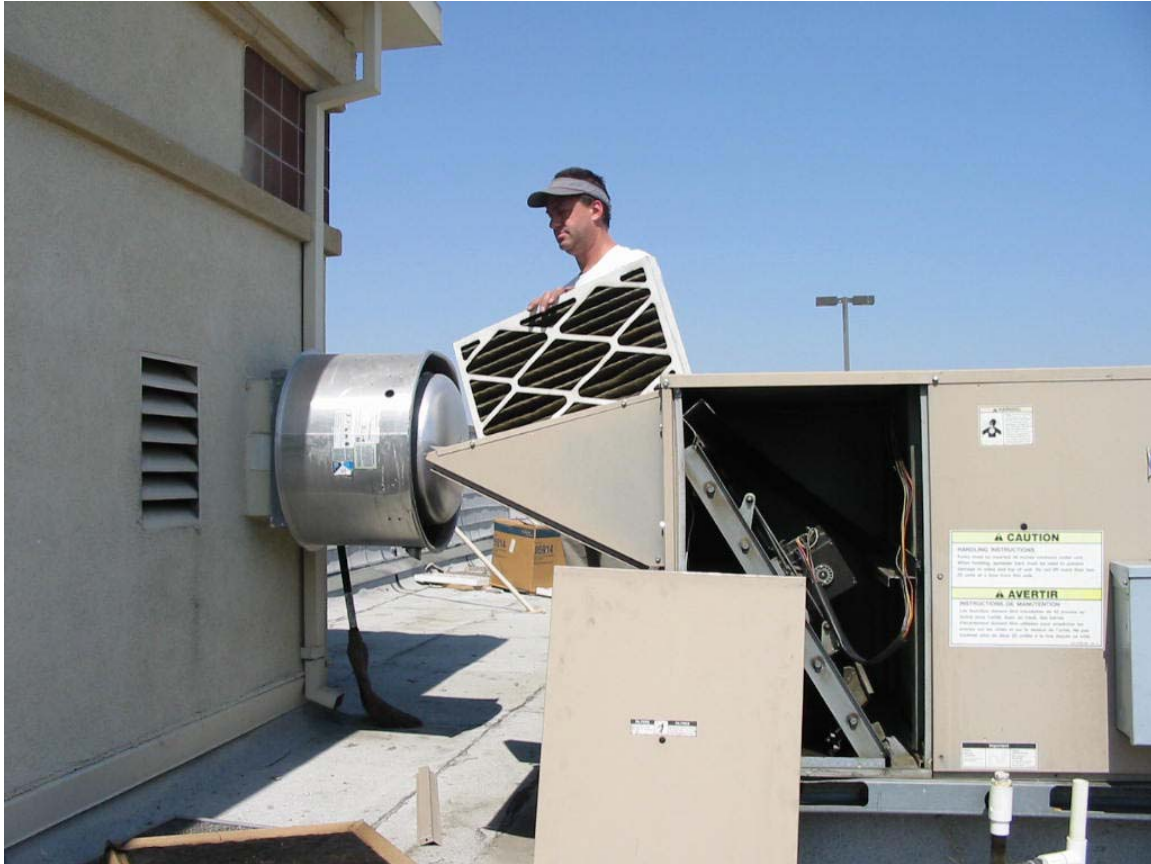
Building exhaust fan discharging directly into outdoor air intake

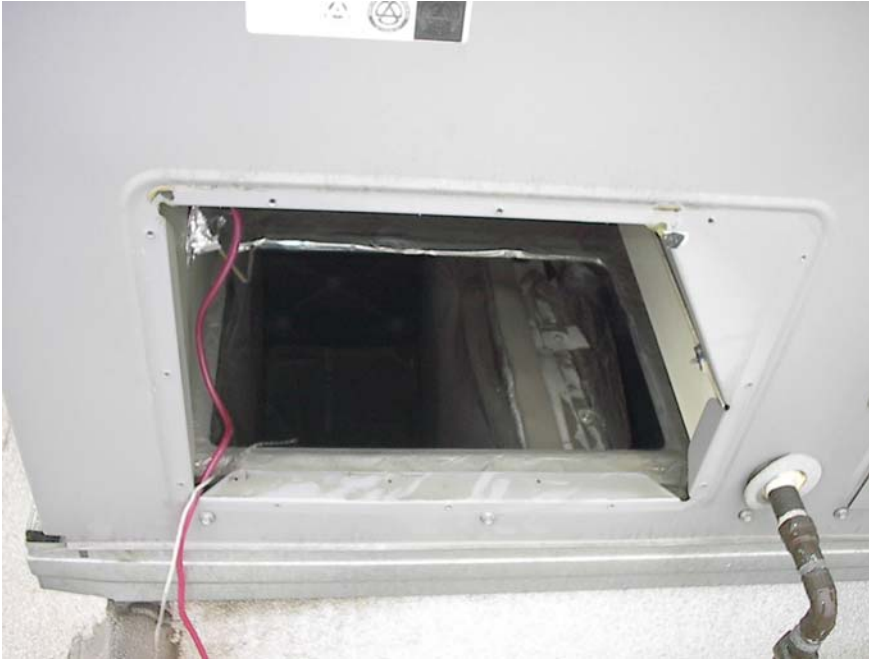
The units were installed with an incompatible curb, allowing supply air to short circuit into the returns, as shown below:

Misalignment of unit supply and return outlets with building ductwork

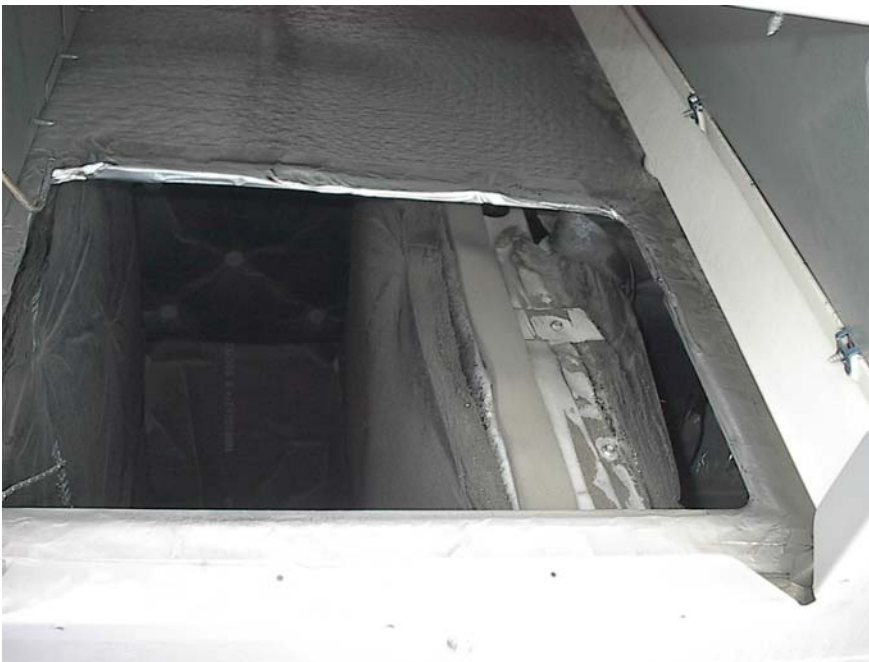
Close-up of unit supply plenum showing bypass into return side

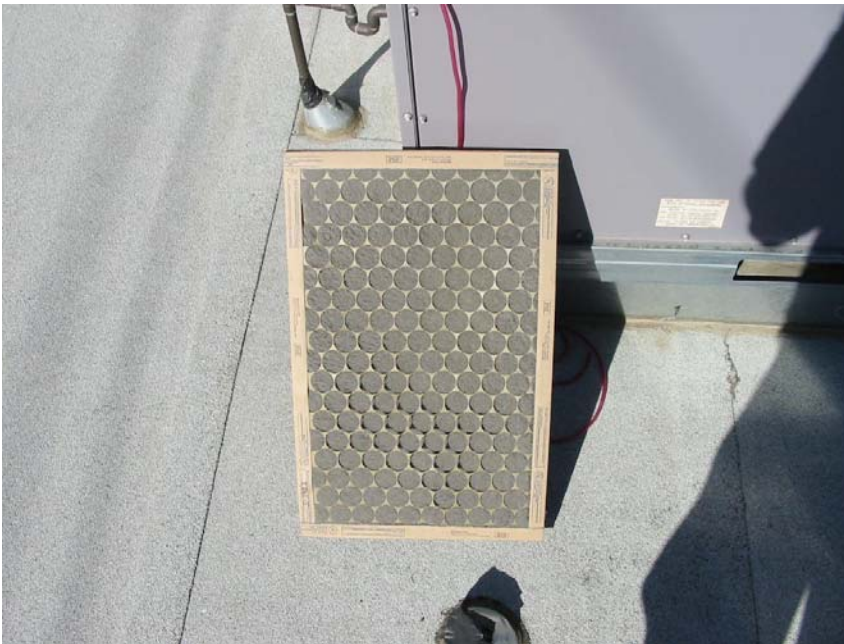
Filter as removed from system

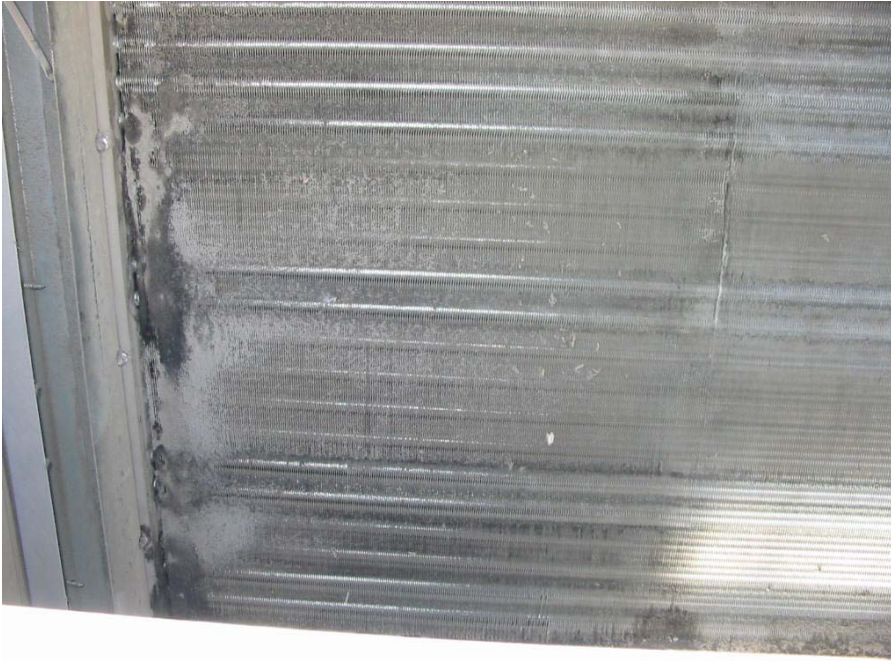
Indoor coil dirty and showing signs of corrosion.

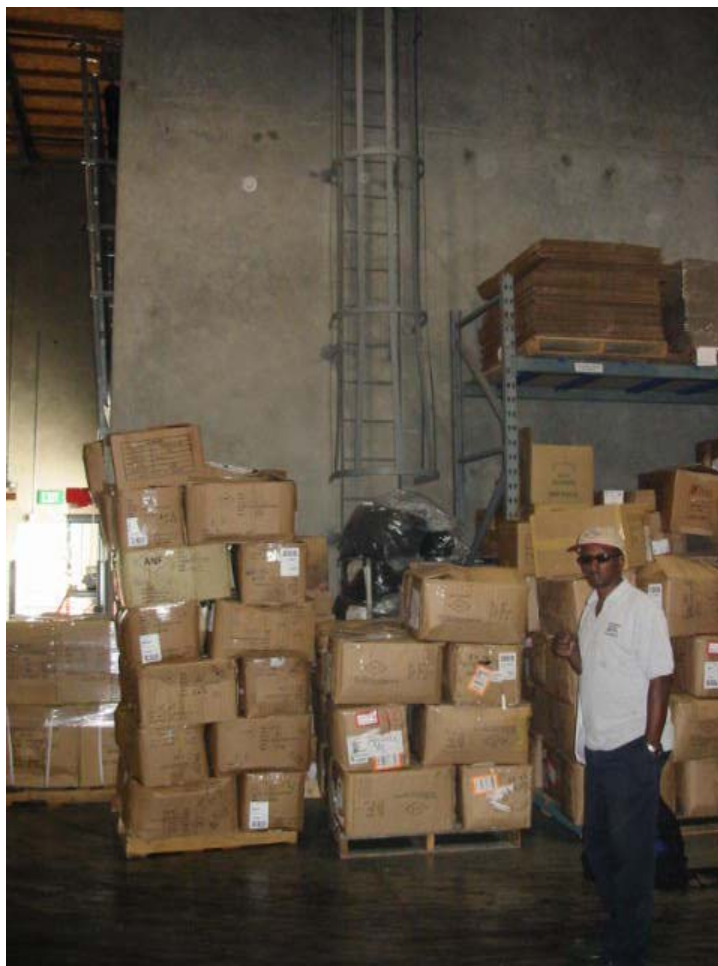
Unit AC-1 had bent condenser fan blades and a missing wire on the control board. Maintenance access was poor due to materials blocking access to roof hatch ladder.

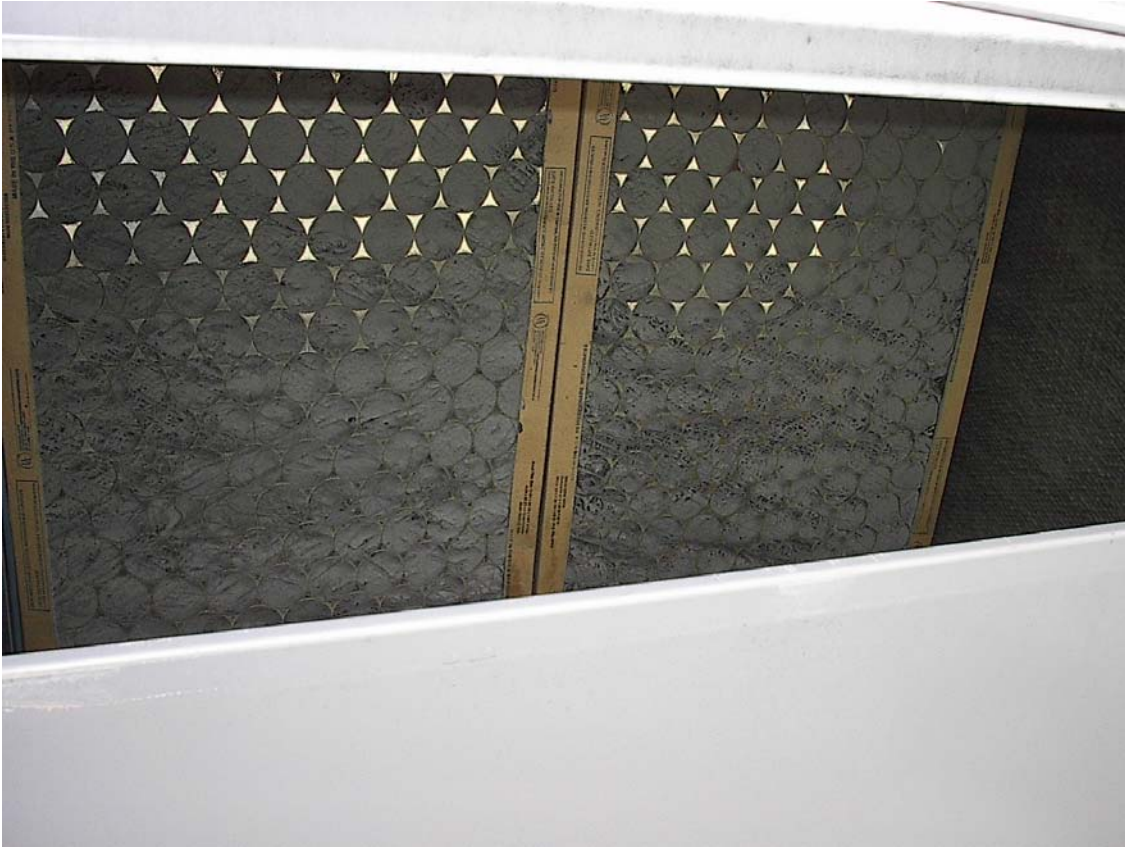
Filter condition at Young Nak Church

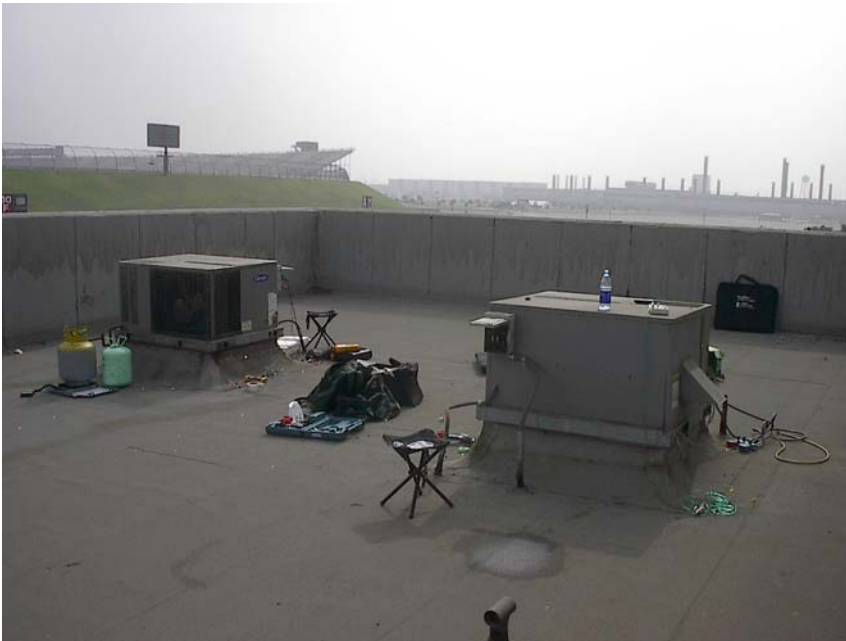
Rooftop units serving new addition.

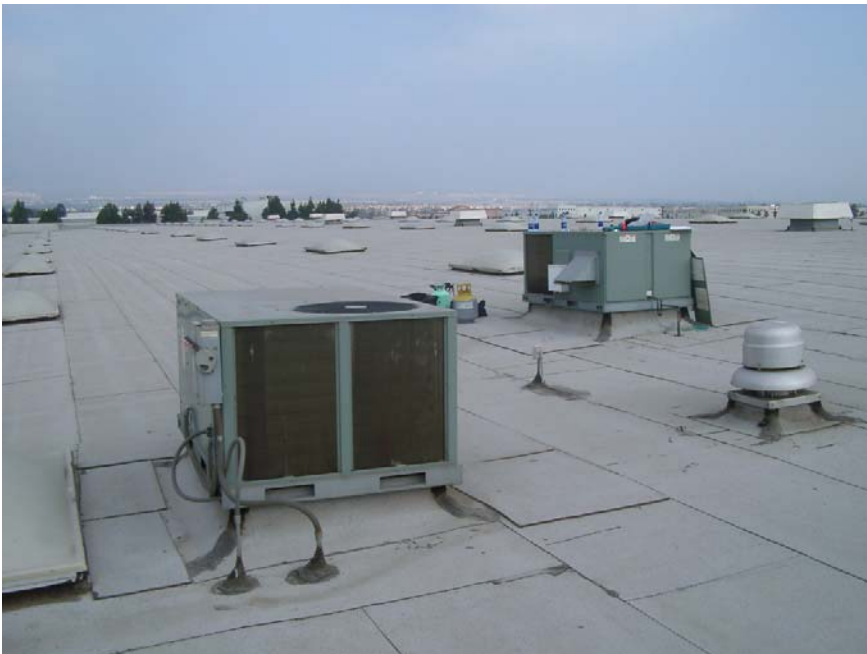
Two Rheem packaged rooftop units conditioning the office.

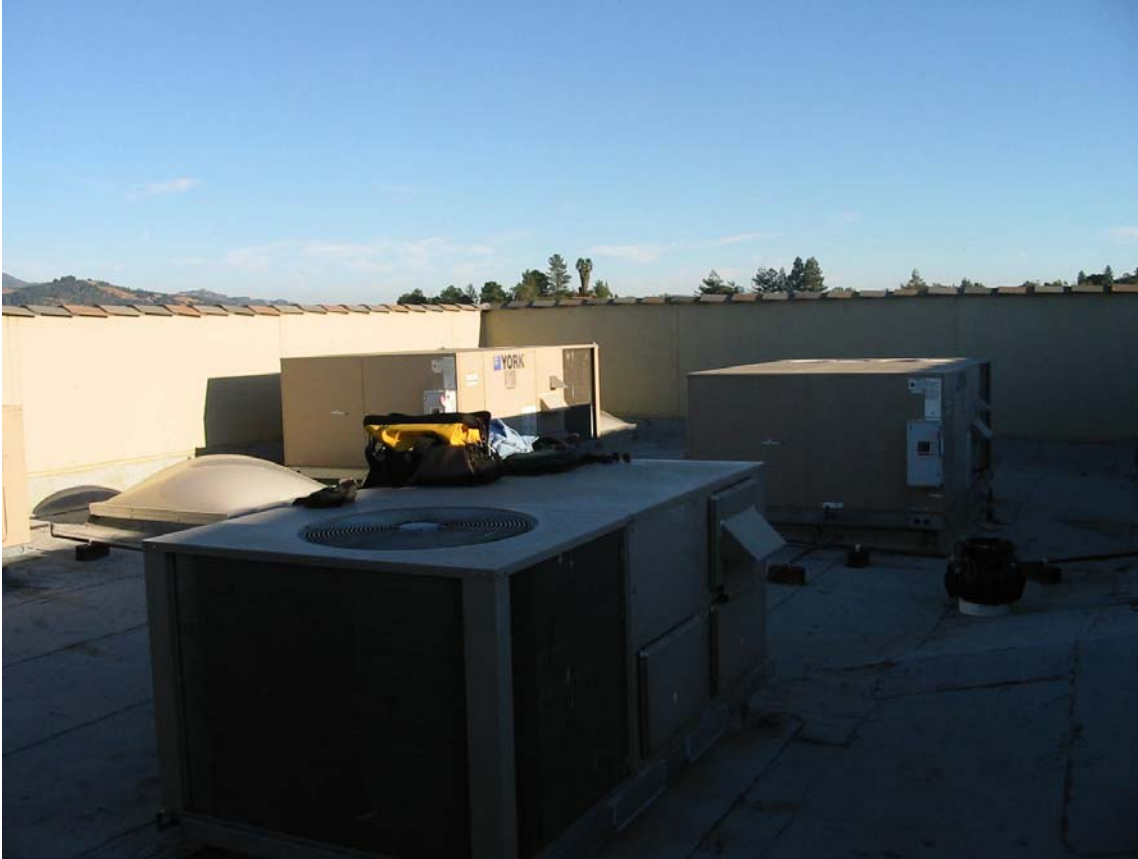
Clover Springs Rec Center Rooftop Air Conditioners
